Lordsburg Playa SDS Nature-Based Management Case Study

Lordsburg Playa is a large, generally dry, lakebed located west of Lordsburg New Mexico. The Playa is crossed by Interstate 10, a major road across the south of the United States.

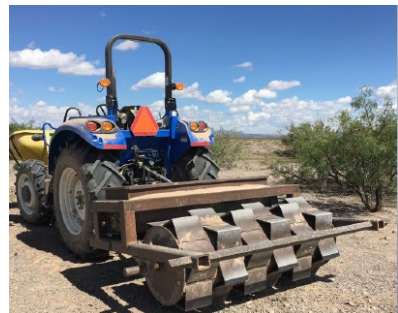
Tractor with imprinter. Source: Lordsburg Playa Watershed Restoration to Reduce the Severity of Dust Storms on I-10.

- Keyline plowing, a process of digging deep lines in the soil along contours but in a way which does not turn over the soil. These keylines allow rain and run-off to soak into the soil.
- Imprinting the soil, creating small depressions which can catch rainfall, windblown seeds and disrupt wind speeds across the ground to reduce wind erosion.
- Installing one-rock dams and “Zuni Bowls”¹ to slow erosive water flows and reduce the generation of more dust which can be picked-up in the wind.

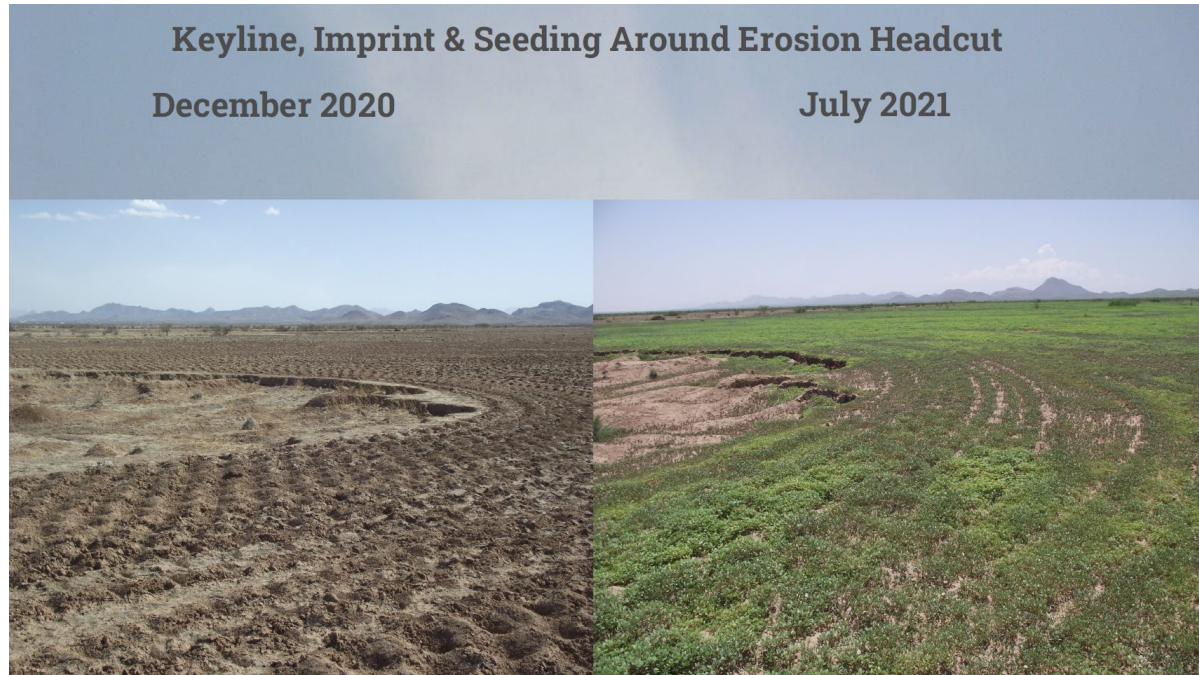
Comparison of treated land from December 2020 to July 2021. Source: Lordsburg Playa Watershed Restoration to Reduce the Severity of Dust Storms on I-10
